Port and Terminal Risks

Quay Container Cranes

Risks & Loss Prevention Actions

Shoreside Cranes – Post Incident Investigations

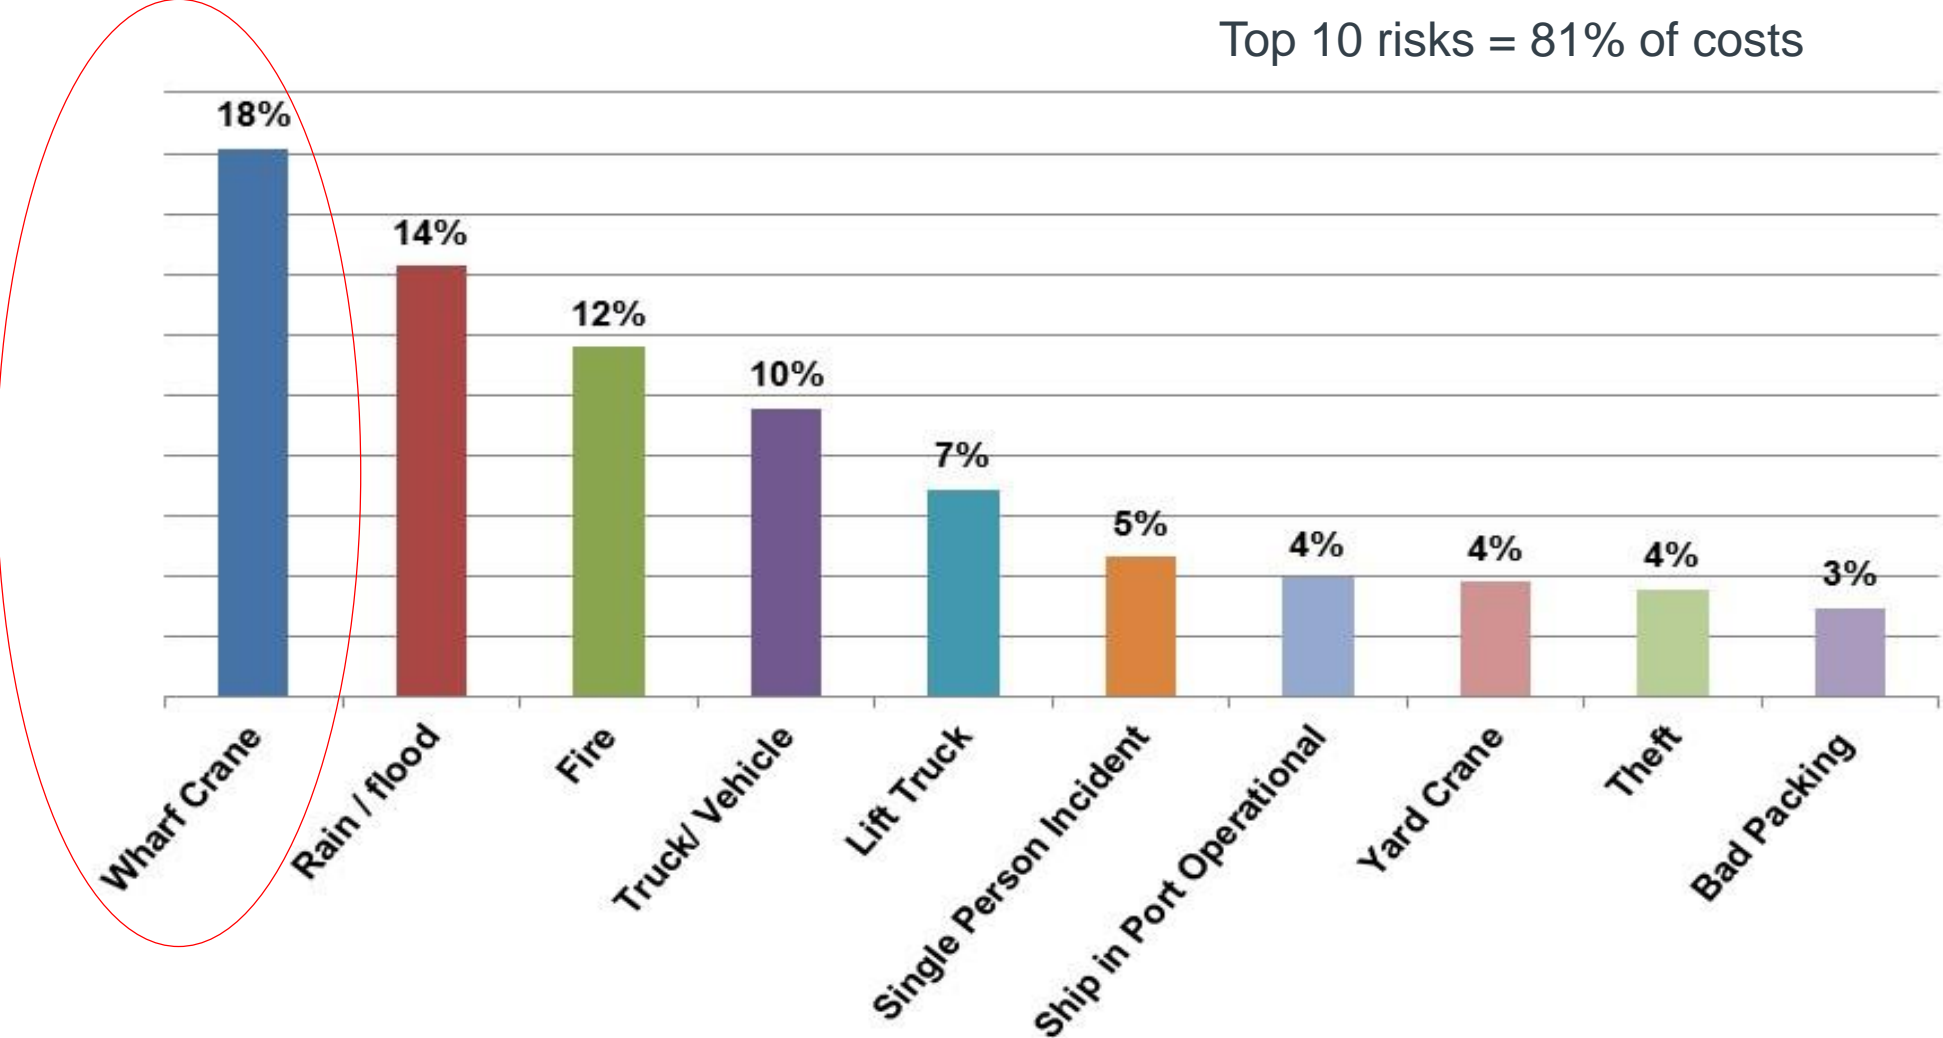
Port & Terminal members
All claims top risk costs

Top 10 risks = 81% of costs

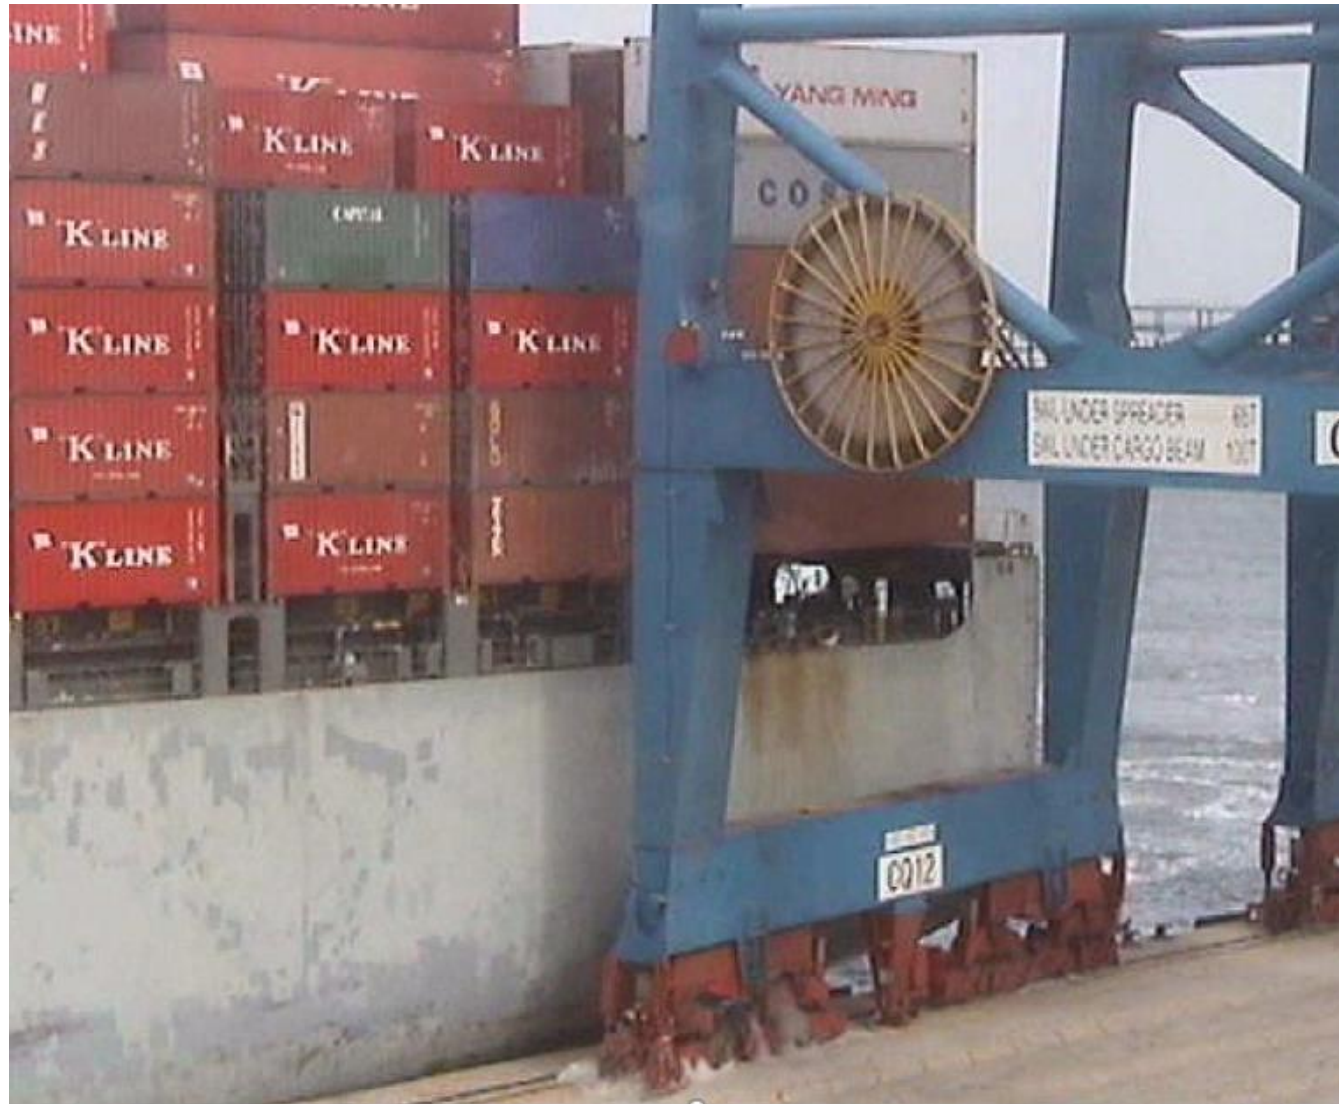
Case Study 1 - Vessel Contact During Berthing

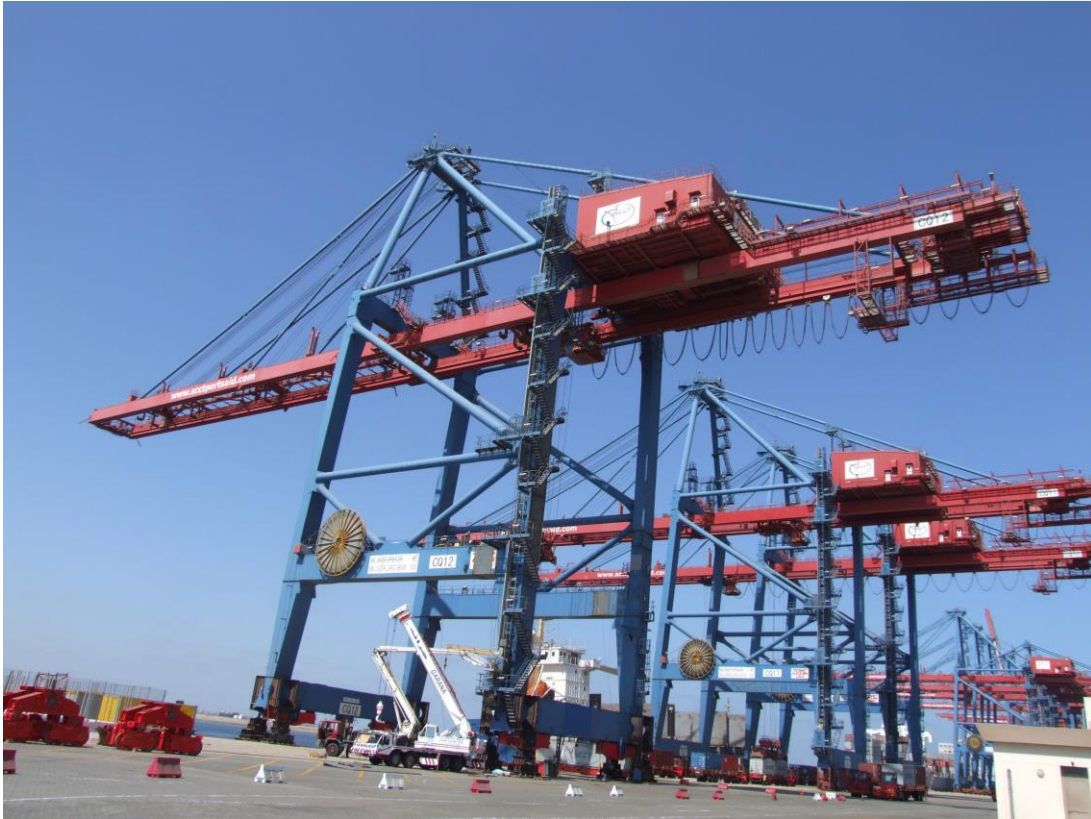
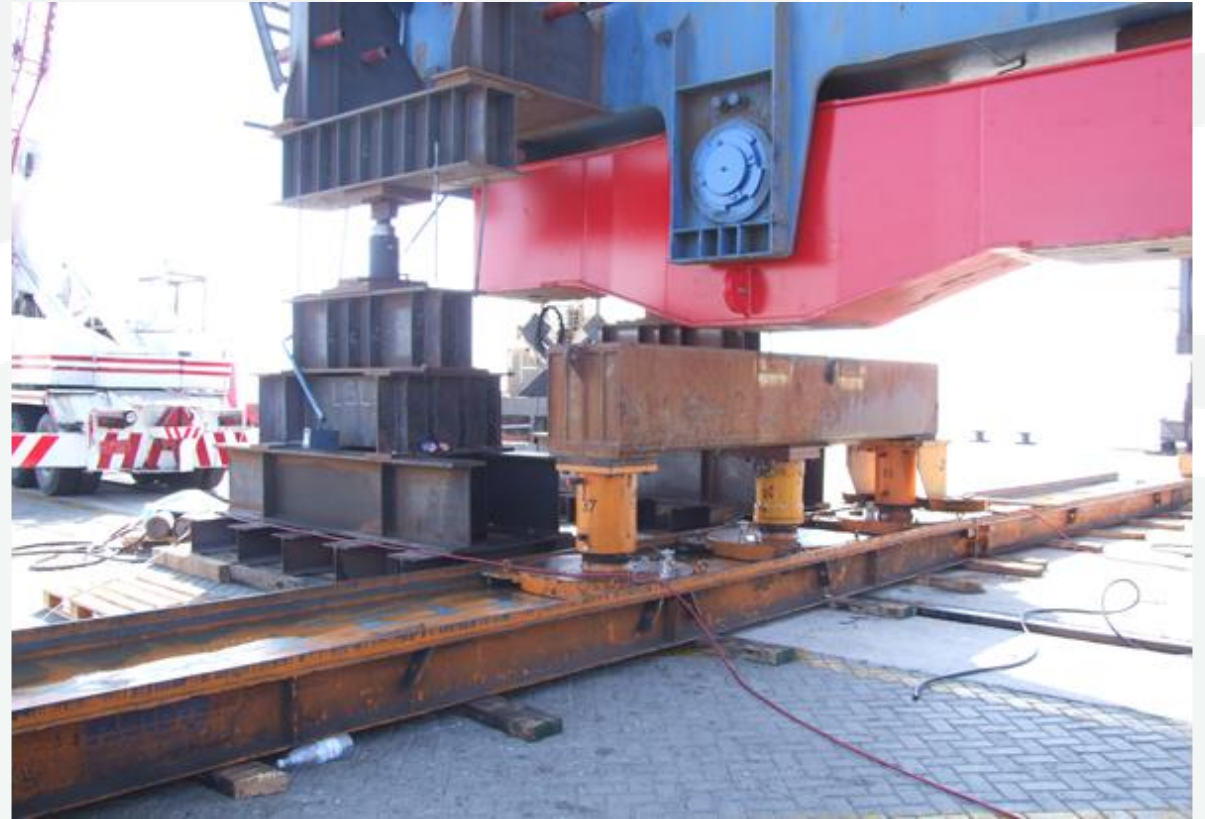
The repairs were effected insitu on the quayside and in the vicinity of the running rails. Crane supported by temporary erected structures and jacks. Note also three floating jacks (coloured yellow) below the jacking beam and constrained in their glide tray.

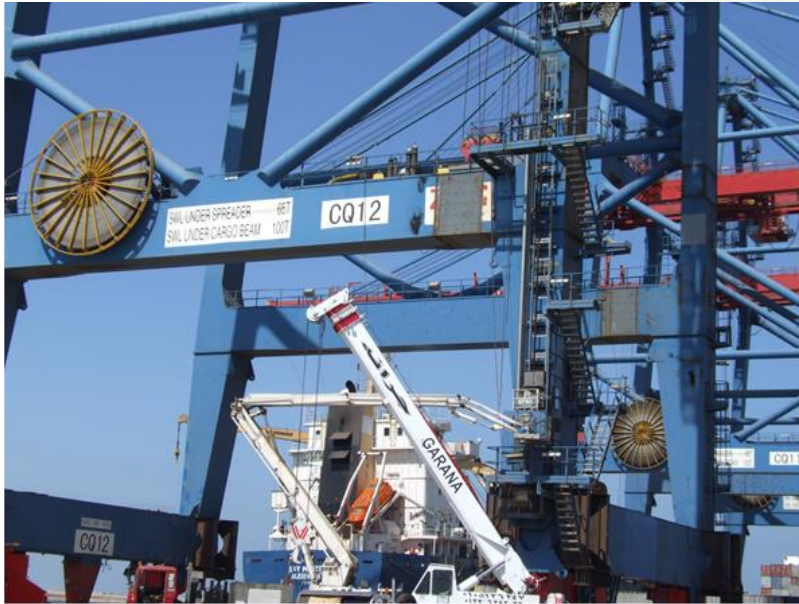
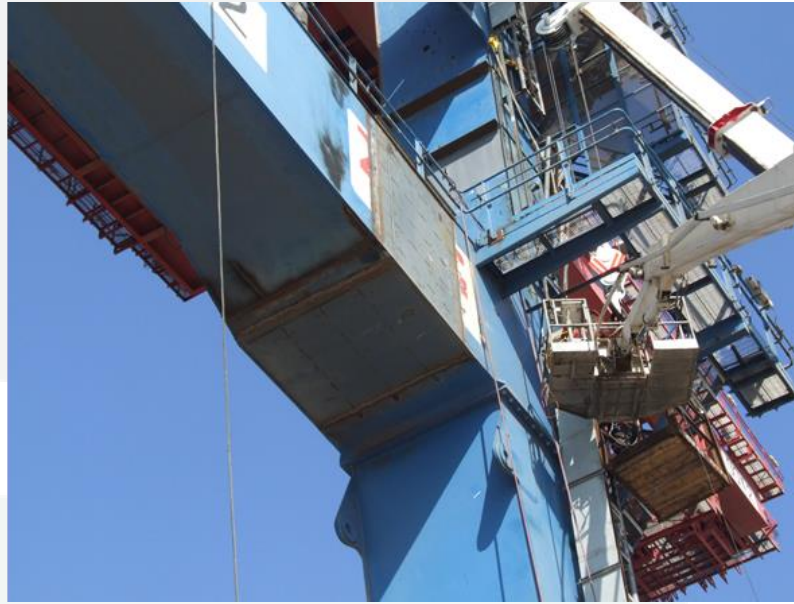
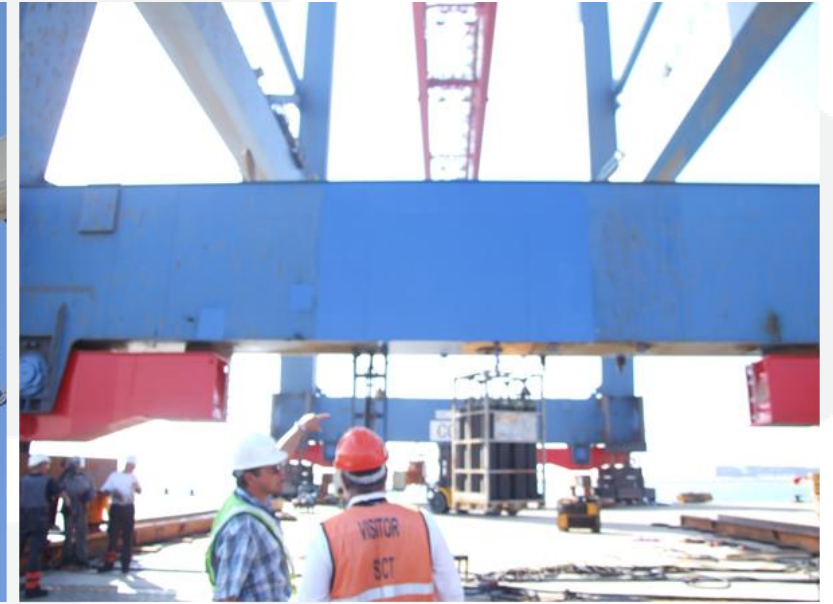
Multiple structural components were repaired with inserts such as the left and right portals, and sea side legs:

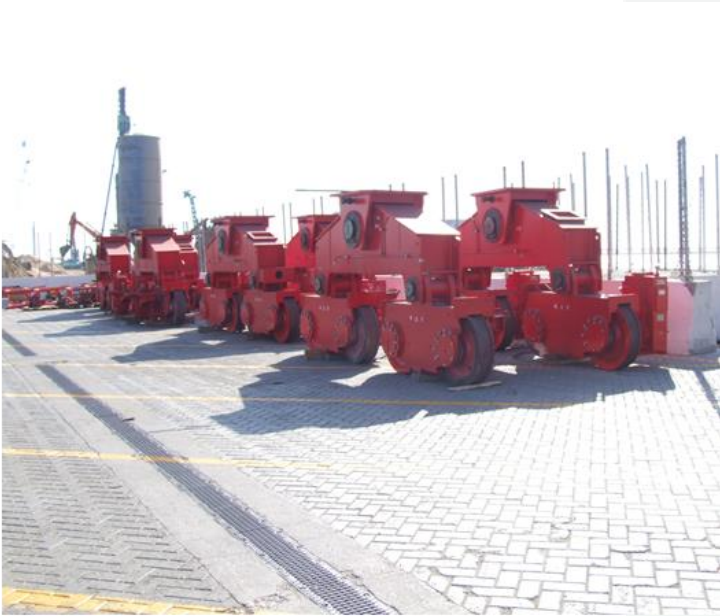
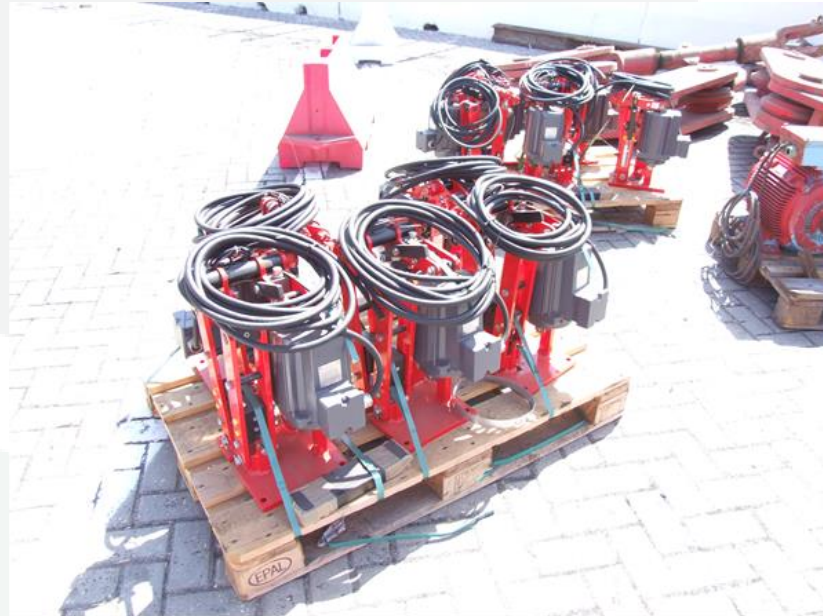
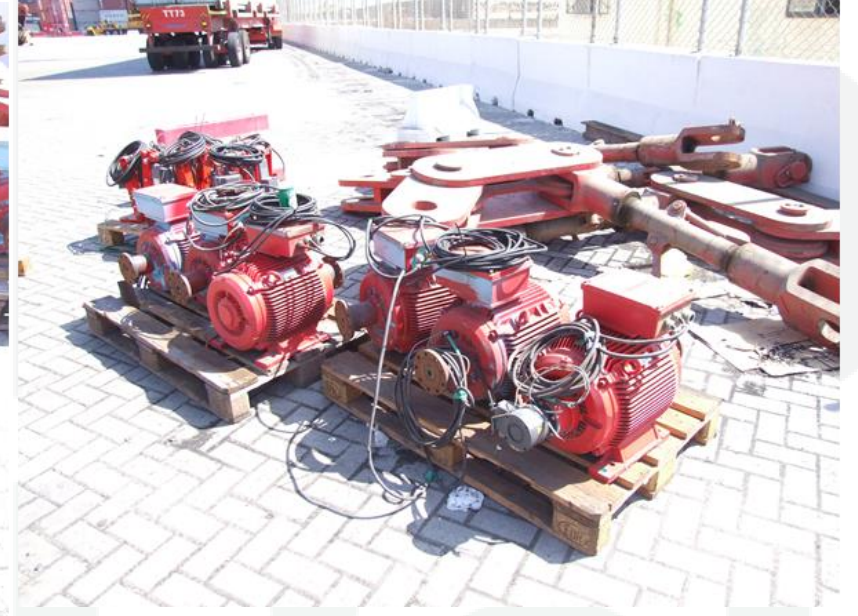
The crane was hydraulically jacked up in order to replace all the bogies, drive motors and brake components:

Final repair cost was in the order of US 3 Million

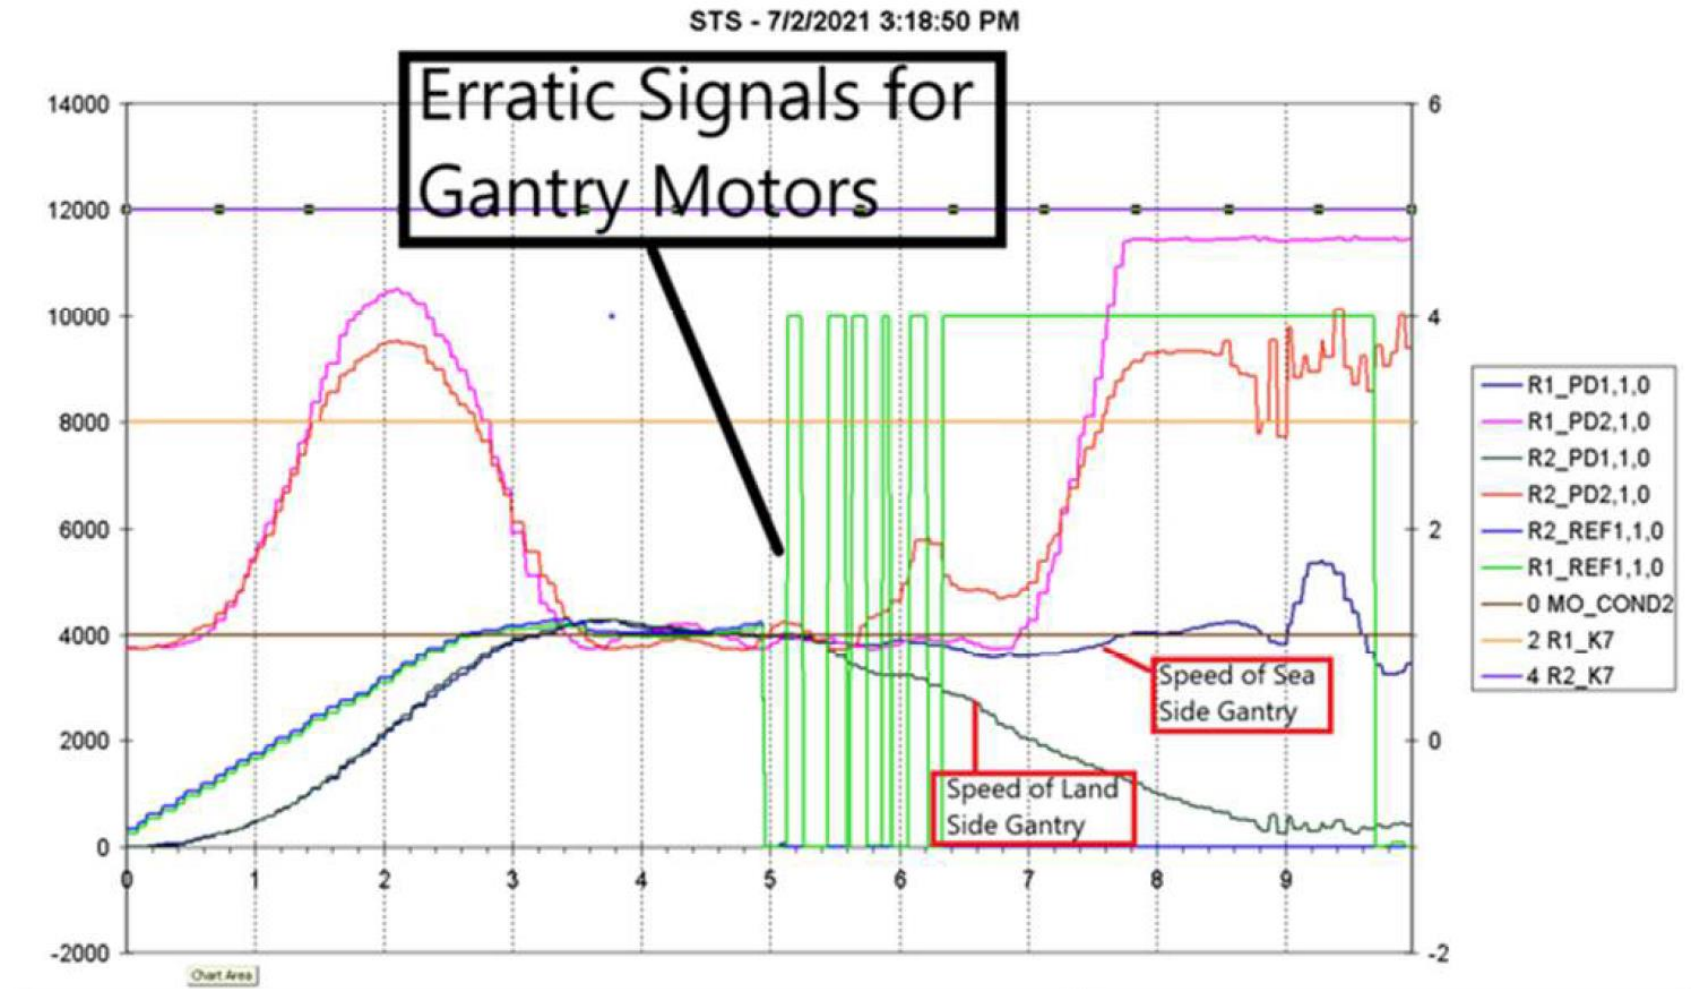
The crane software data was interrogated. It was discovered that the recently updated software conflicted with the existing system causing a communication error and erratic signals being sent to the motor drives for the land side and sea side legs of the crane.

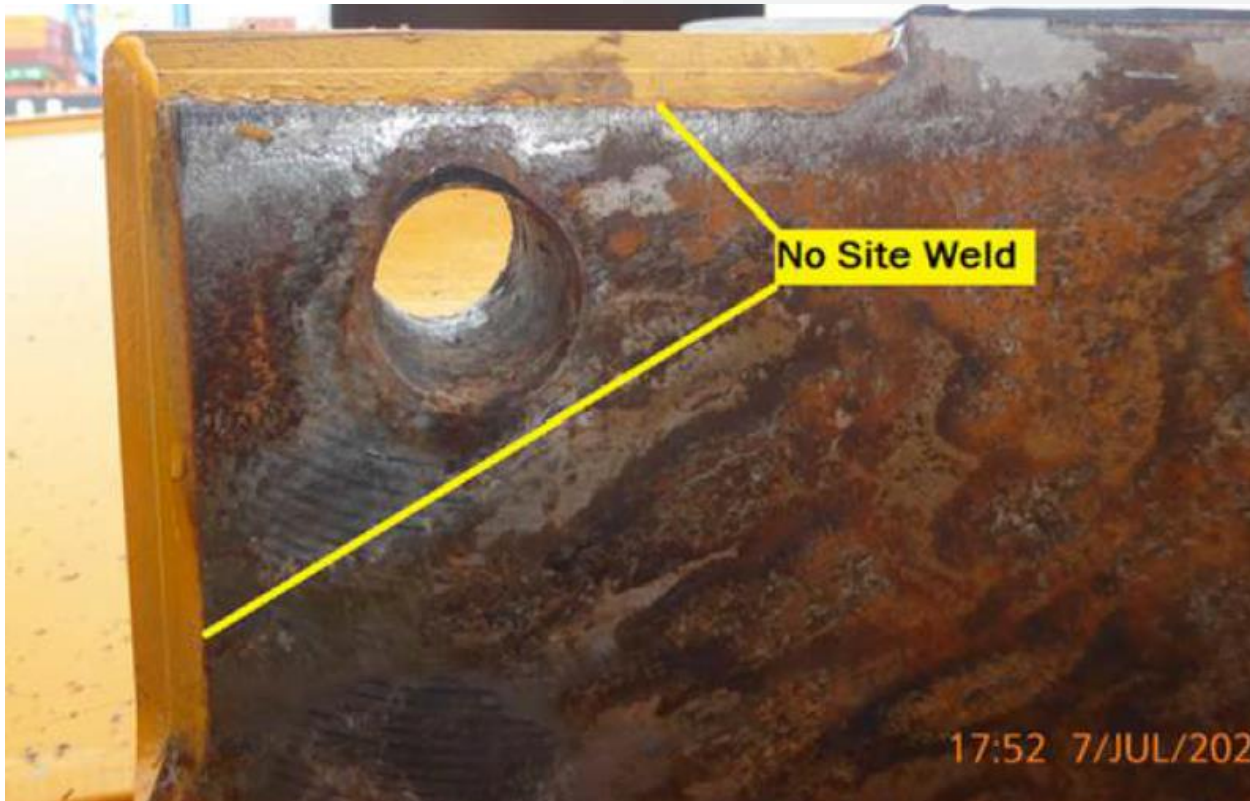
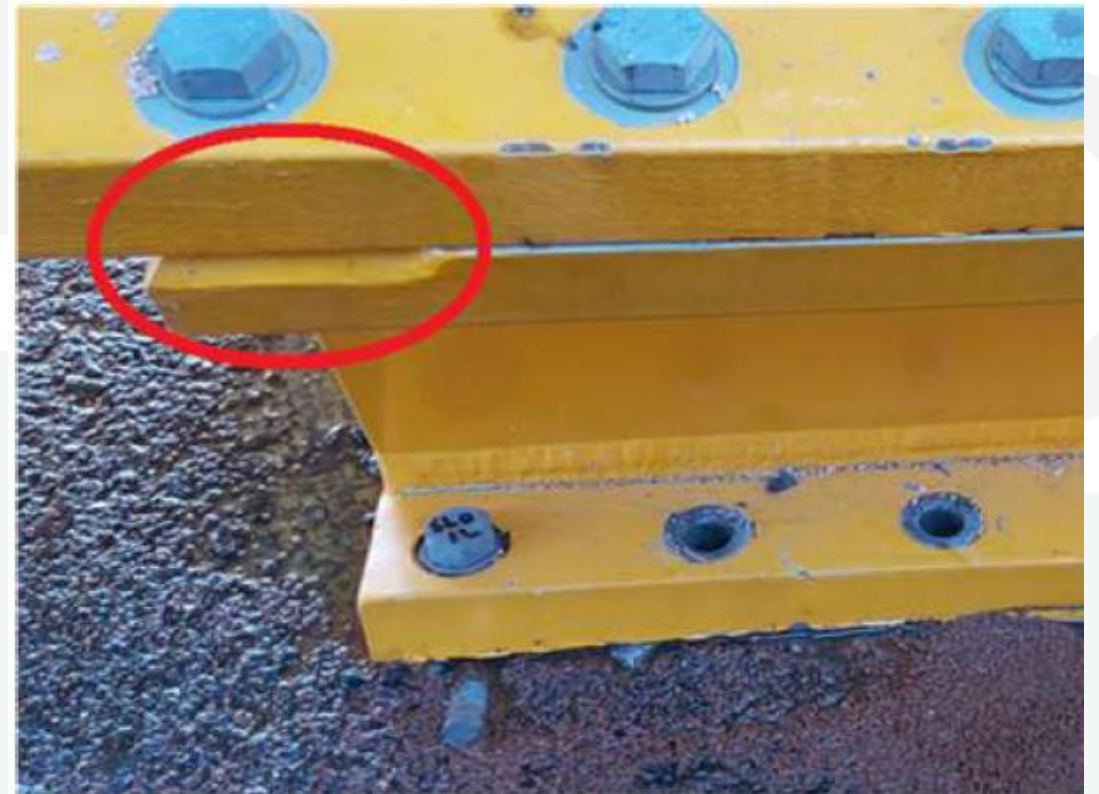
In addition, we noted that the bogie connection pieces had not been correctly fitted when the crane was installed.

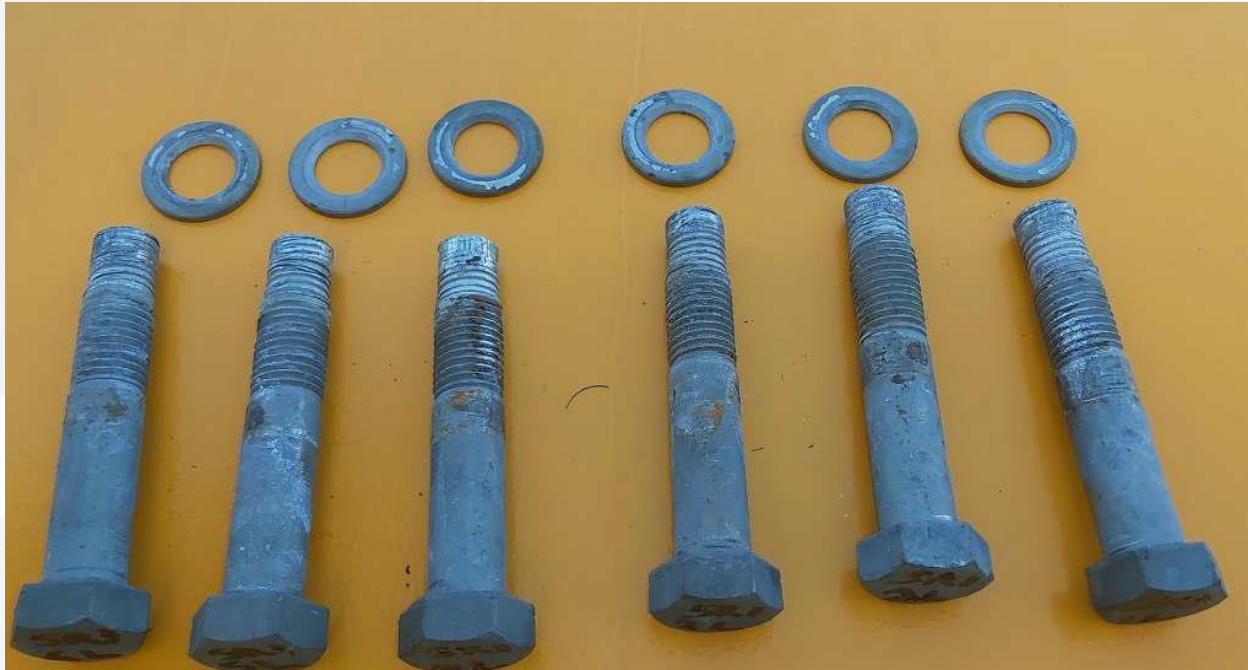
Our metallurgical inspection of the bogie connection bolts confirmed their failure mode.

The recovered bolts fitted to the left-hand connection piece had failed in shear whilst those fitted to the right-hand connection piece, had failed in overload.

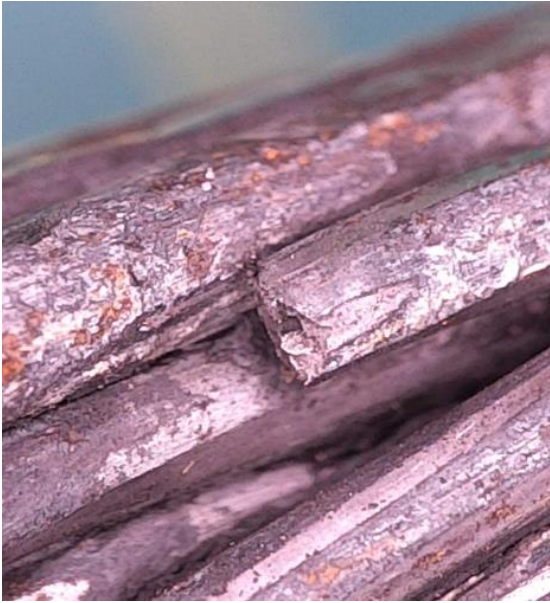
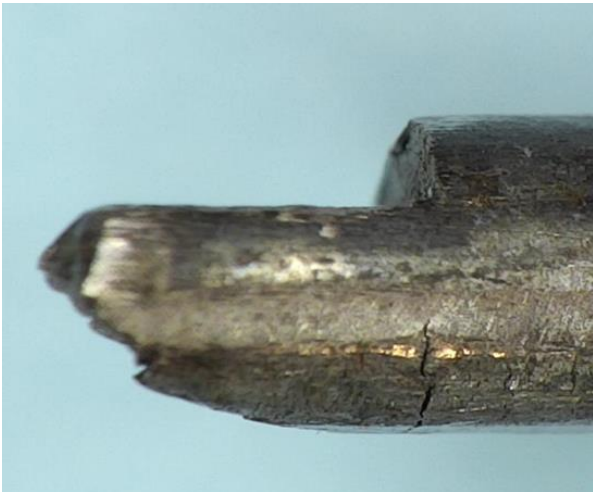
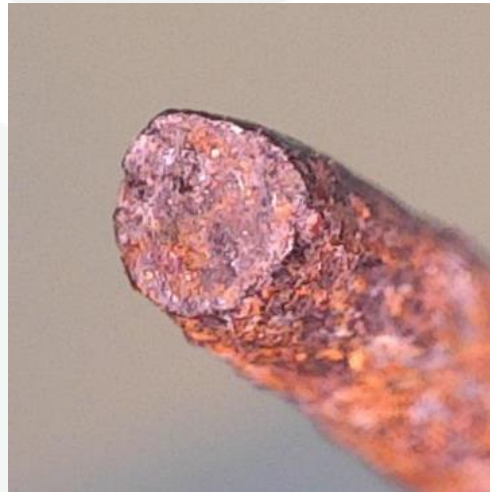
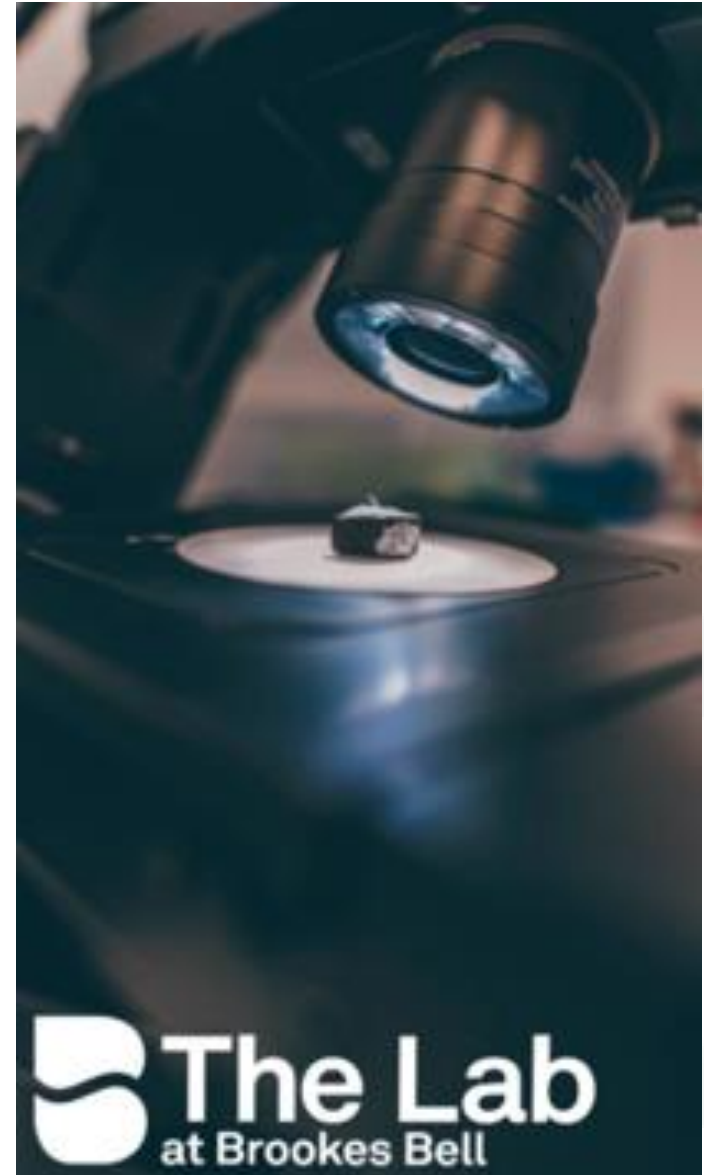
Wire Failures - Microscopy

Scanning Electron Microscopy – Images Courtesy of Casar Ropes

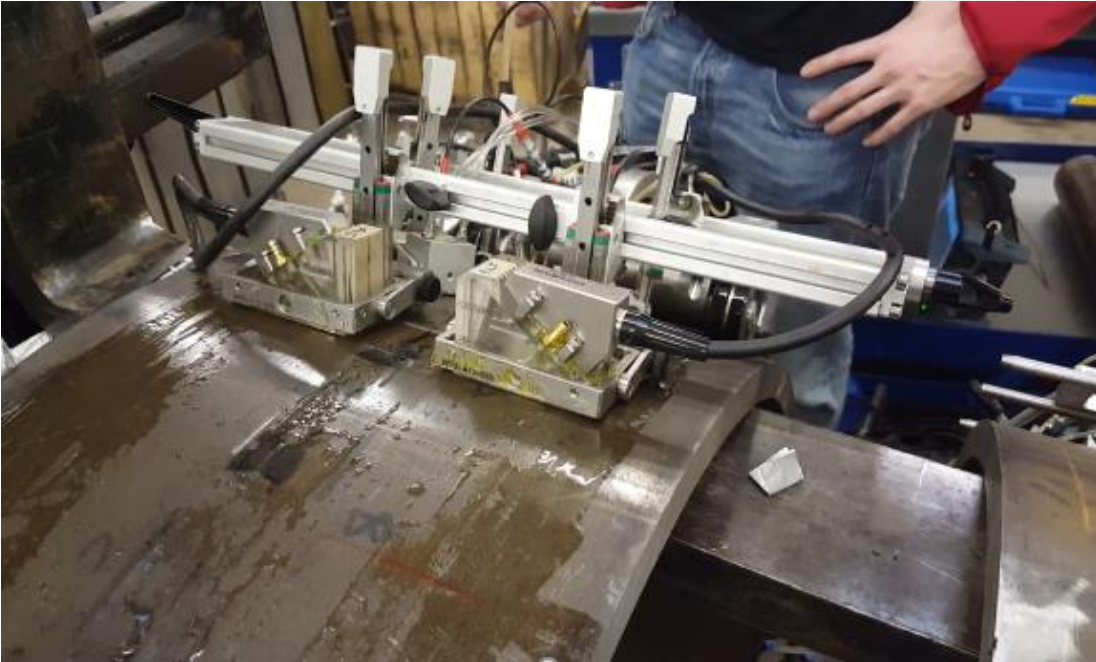
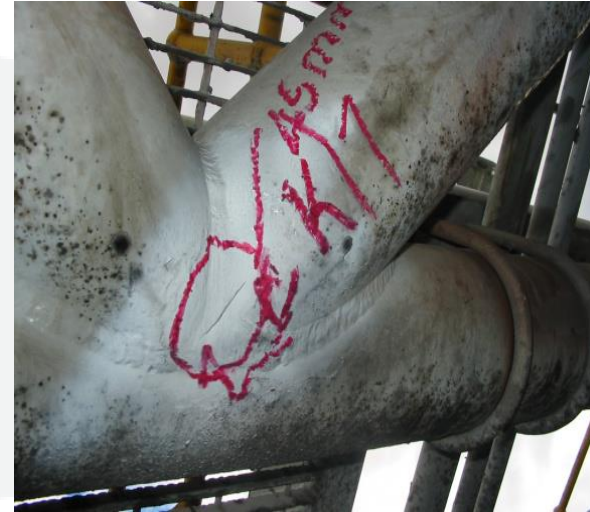
Performing visual inspections can highlight structural defects, such as cracks and indentations on box beams before failure occurs.

Regularly performing NDT tests, such as Ultrasonic Thickness Measurement (UTM) and Magnetic Particle Inspections can reveal hidden defects and confirm the structural integrity of the asset.

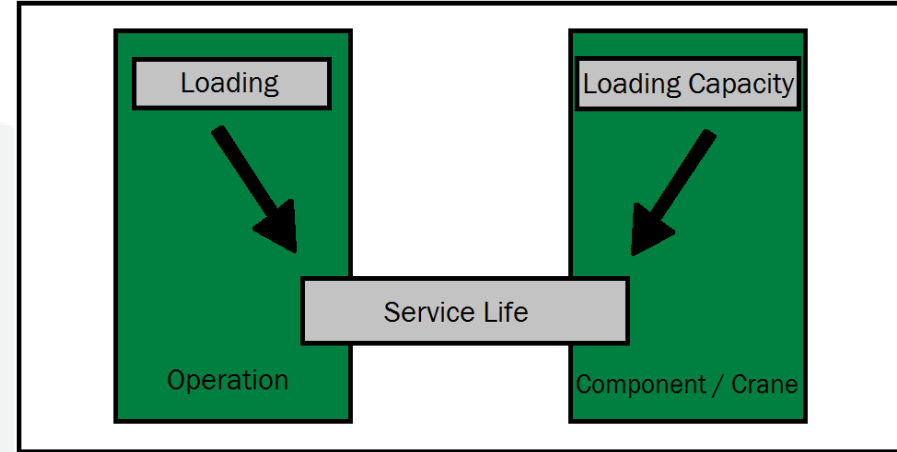
Proper application of rules, such as FEM, at the design stage to establish safe working limits on both load and lifespan of the crane

Finite Element Analysis carried out to determine stress concentrations and enable for adequate structural modifications/repairs
