GUIDELINES FOR THE CARRIAGE **OF CARGO IN NON-OPERATING** REEFER **CONTAINERS**

COA Guidelines

TT Club StopLoss Briefings

CINS Guidelines

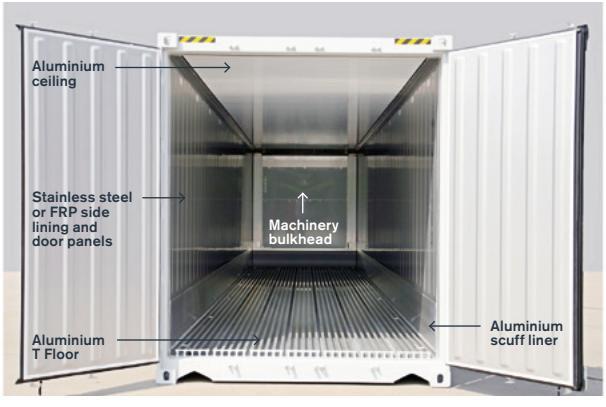
Picture 1

Interior view of a refrigerated container showing aluminium T-Floor and scuff liner, stainless steel or Fibre Reinforced Plastic (FRP) sidewalls, white painted aluminium ceiling, machinery bulkhead at far end.

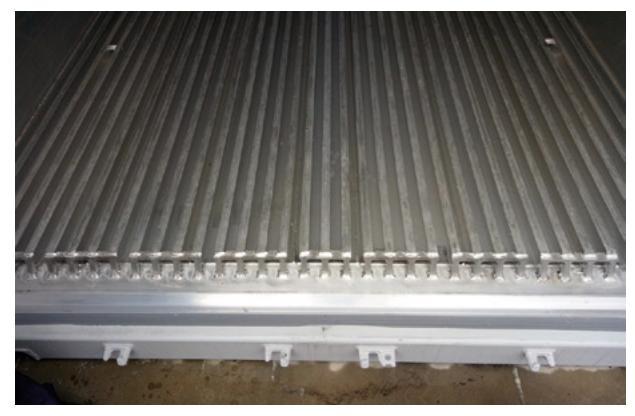
Picture 2

Close up of aluminium T Floor. This is an in-service container with some minor discoloration but otherwise in good condition.

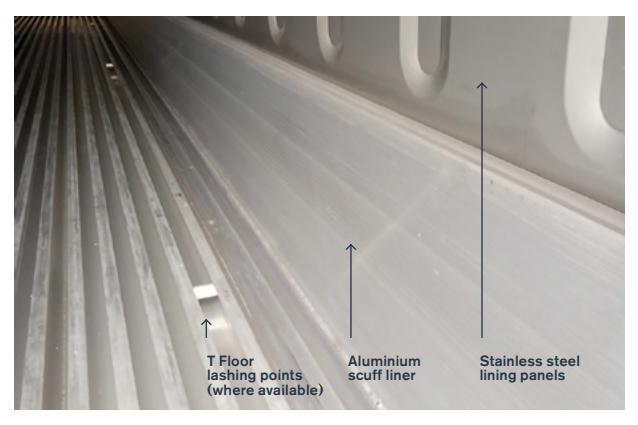
Picture 3

Interior floor/sidewall interface showing lashing points and exposed metal surfaces. Note that there may be no lashing points in the floor.

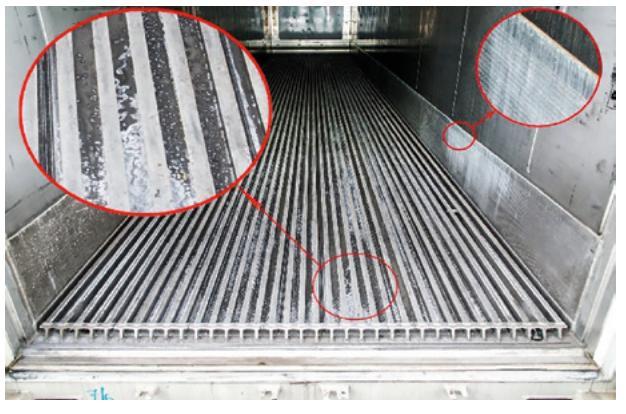
Picture 4 Corrosion to aluminium T Floor and scuff liner.

There are various causes for the type of corrosion that are presented in Picture 4. Although the most common cause is the cargo itself, including treatments (e.g. residues of fumigation) that might be applied to the cargo, cleaning with caustic materials will also cause corrosion or oxidation to the interior of the unit. Note that fumigation is not allowed in operating reefers; shippers should ensure fumigated cargo is adequately ventilated before packing the container. It is difficult to treat and permanently repair this corrosion as the surface of the aluminium has had its protective oxide layer contaminated.

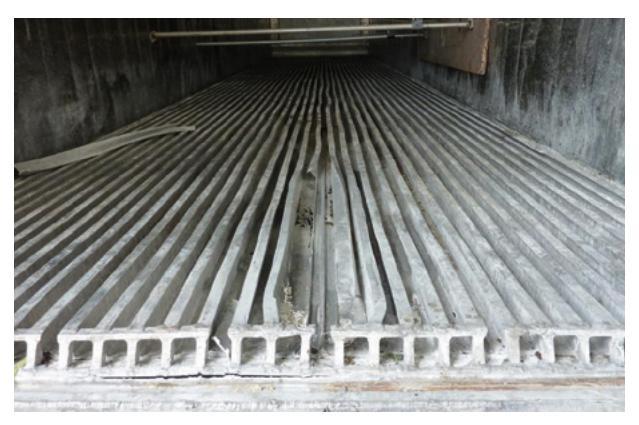
Picture 5

Badly damaged aluminium T Floor showing broken T sections, cracks to the welds which will require major and expensive repairs.

In addition to corrosion, the aluminium T Floor sections are susceptible to mechanical damage, such as caused by fork or pallet truck wheels.

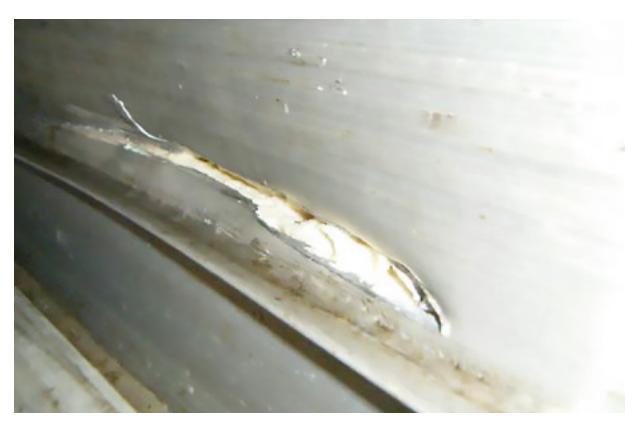
Picture 6

Forklift or cargo damage to the aluminium scuff liner showing the insulation foam underneath.

Most reefer interior sidewalls are protected by aluminium scuff liners. Aluminium is a softer material than the steel used in GP containers, so can be more easily cut by forklifts used during the packing/unpacking process or by the sharp edges of packaging, such as pallets. Some reefers use Fibre Reinforced Plastic (FRP) as lining material, which is more resistant to damage. Cuts in the scuff liner or sidewall, as shown in Picture 6, allow moisture into the insulating foam that needs to be repaired before the insulation deteriorates.

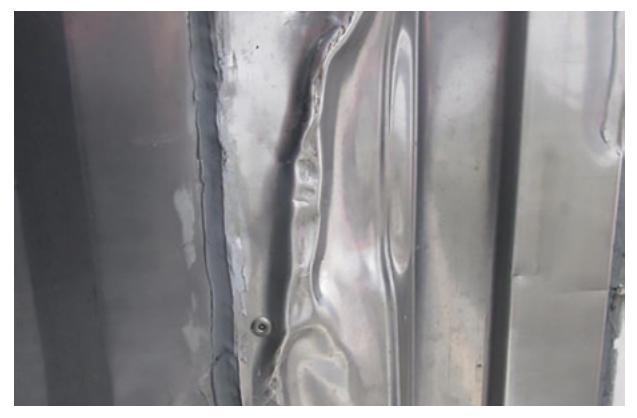
Picture 7 Cargo damage to the stainless steel side lining.

While reefer interior sidewalls might be made from high strength stainless steel it is only 0.7mm thick compared to the 1.6mm or 2.0mm Corten steel used for GP containers. Stainless steel sidewalls are therefore more easily damaged, as in Picture 7, and require more complex repair.

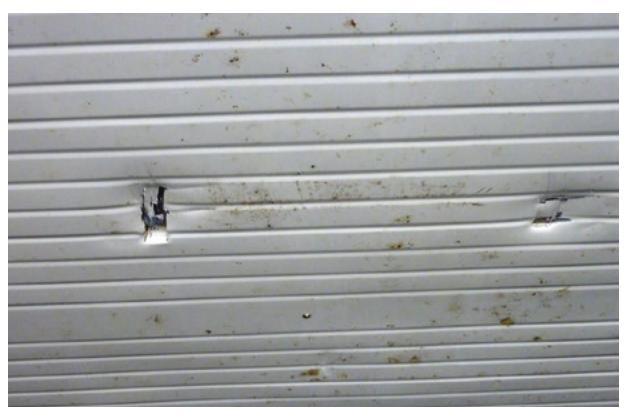
Picture 8 Cargo or forklift truck mast damage to the aluminium ceiling panels.

The thin panel aluminium ceilings are significantly easier to damage than the Corten steel used in the roofs of GP containers. Such damage, showcased in Picture 8, exposes the insulation foam and must be repaired to prevent moisture absorption.

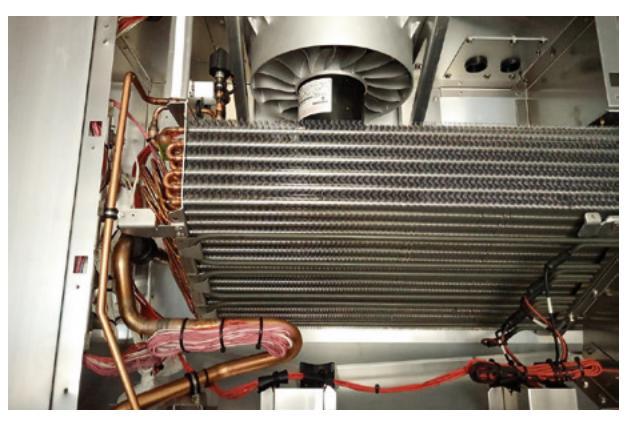
Picture 9

View of reefer machinery on a new unit with the bulkhead removed.

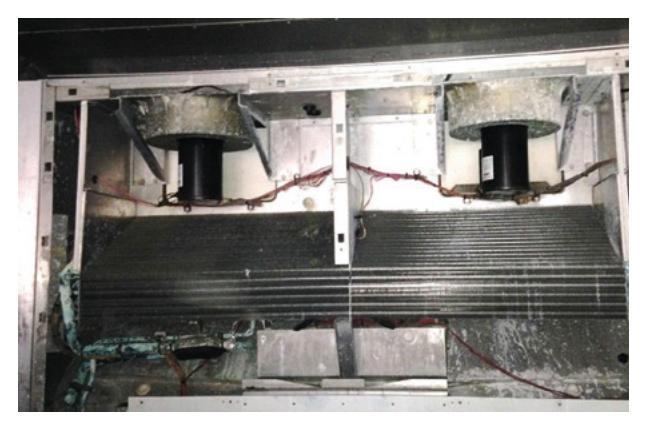
Picture 10

View of corroded reefer machinery with the bulkhead removed. Note the white corrosion or oxidation to the aluminium fan housing and the copper corrosion to pipes. The damage is most likely resulting from previous cargo or a cargo treatment, but whatever the actual cause, inadequate operational controls (including excessive cleaning) are likely to lead to costly repairs being required.

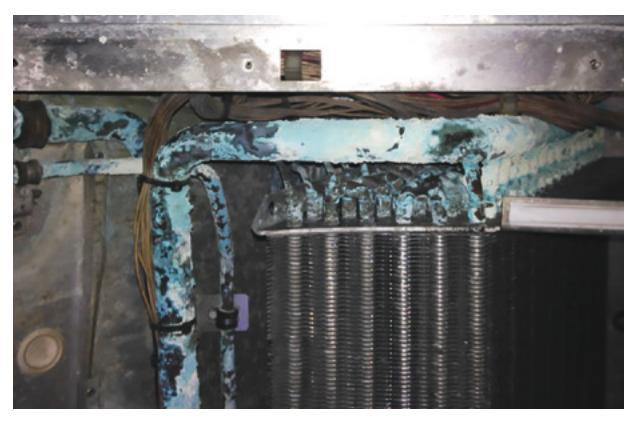
Picture 11

Close up view of corroded reefer machinery copper pipes.

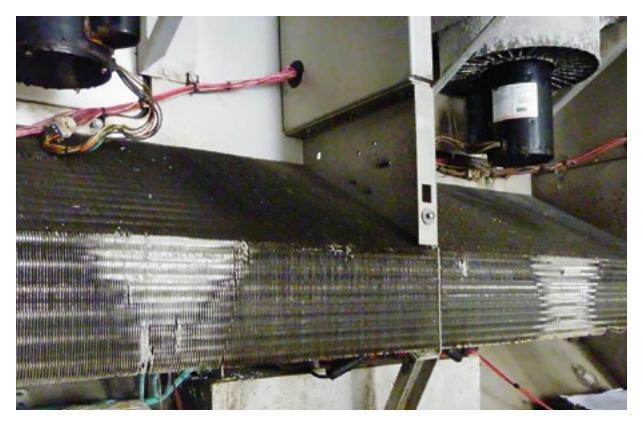
Picture 12 Damage to the evaporator coils.

A hard impact to the aluminium bulkhead can damage the evaporator coil behind it, crushing the fins or flattening the refrigerant tubes (see Picture 12). Damaged coils will inhibit airflow and the ability to maintain temperature settings for future temperature controlled cargoes.

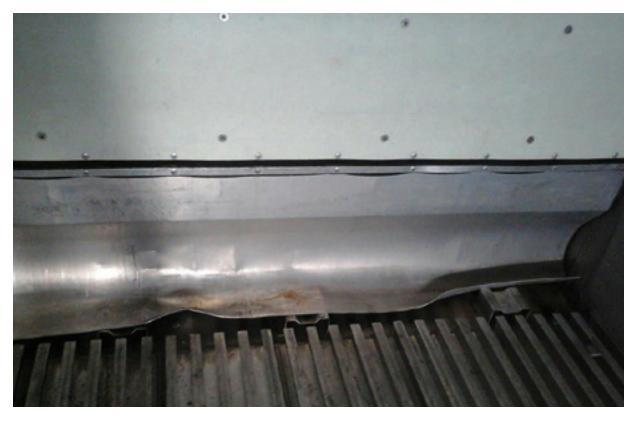
Picture 13 Damage to machinery airflow baffle.

Picture 13 shows damage to the machinery airflow baffle. Cargo that is slid along the floor and pushed into the bulkhead can bend back the air baffle plate which will require replacement.

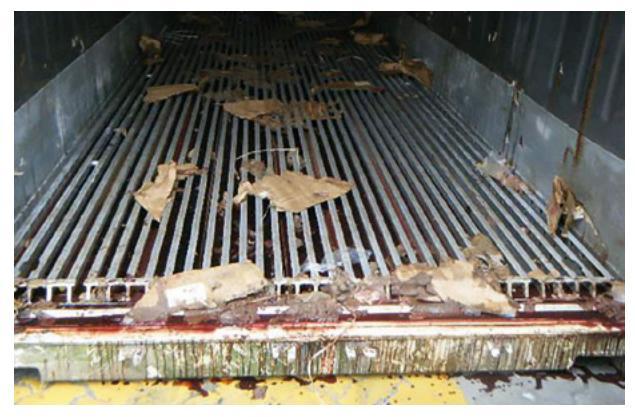
Picture 14

Poorly maintained and/or cleaned reefers, as shown in Picture 14, are unsuitable for use with refrigerated food products, flowers or pharmaceuticals.

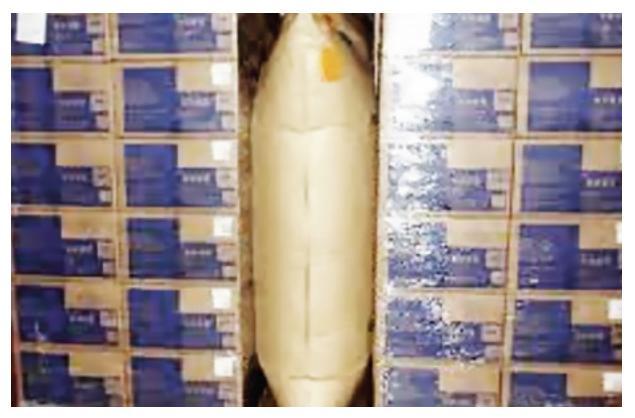
- Use of air bags for dunnage against the sidewalls, may cause severe damage to the unit. If air bags are used it is recommended that they should only be placed in the middle of the cargo. Picture 15 shows correctly placed in middle of cargo.

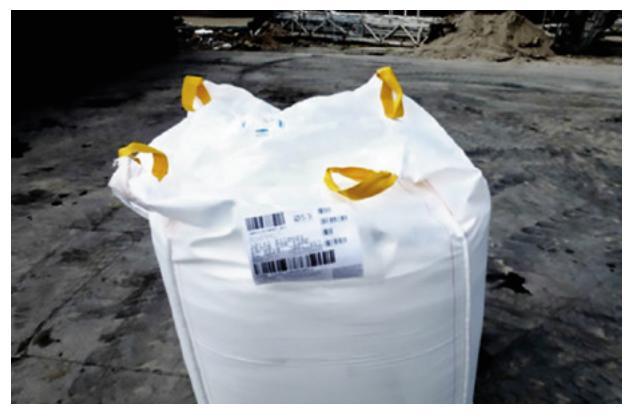
Picture 16

- FIBCs/Big Bags: When packing FIBCs the mass of the packed cargo should not exceed the maximum permissible payload or 27 tonnes, whichever is the lesser
- Cargoes that emit fine powders or grains should be packed in sift-proof and sealed FIBCs, an example is shown in picture 16. Packers should also consider stretch/shrink wrapping to prevent fine powders escaping from the FIBCs
- It is recommended to fit a false floor to reduce the risk of bag material tearing.

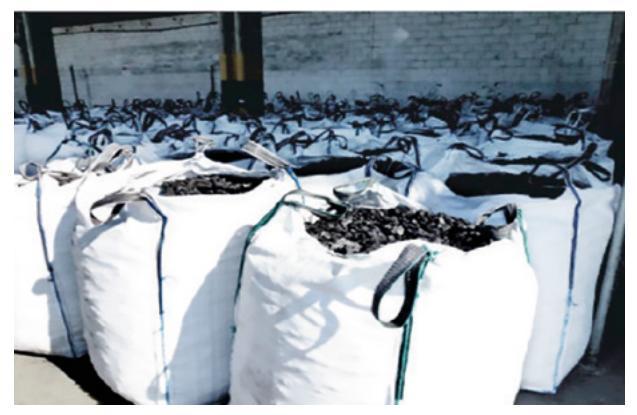
Picture 17

- Cargoes that are (a) inert such as dry plastic scrap, (b) do not emit vapours and (c) not excluded on the list in section 10, can be carried in standard open top or skirted top FIBCs. However, when open top FIBCs (see Picture 17) are used there may be additional costs incurred for cleaning any spillages after the cargo is delivered
- For FIBCs not packed on pallets, it is recommended that a false floor is fitted to reduce the risk of the FIBC fabric tearing.

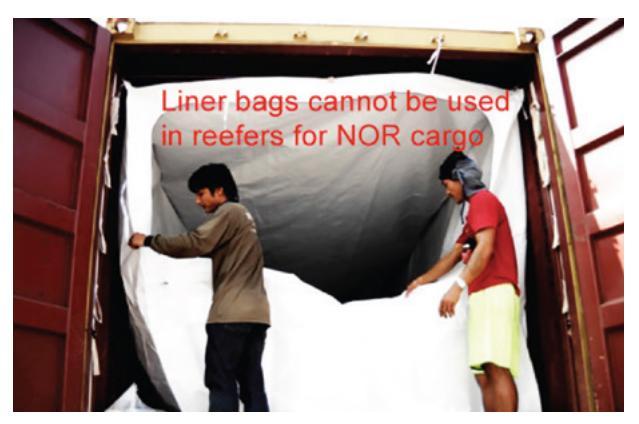
Picture 18

• Liner Bags, as shown in Picture 18, are not suitable for use in reefer containers, whether for temperature controlled or NOR cargo.

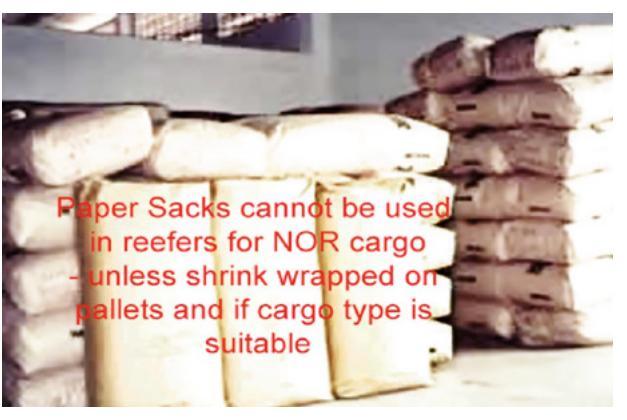
Picture 19

- Drums: Closed, sealed drums can be carried if securely mounted on pallets or if the T Floor and part of the sidewall are adequately protected with plywood. Drums should not be placed directly on to the T Floor or against the sidewalls
- Paper Sacks. When packed as non-palletised cargo, as in Picture 19, these are not suitable for use in reefer containers if they contain heavy or powdered products such as cement, fertilizers etc. Paper sacks packed and shrink-wrapped on pallets may be considered if the cargo type is acceptable.
